LAMPIRAN

PT. GEO STRUKTUR INDONESIA
23 - 12 PIT PEMB JEMBA TA N JONDUL

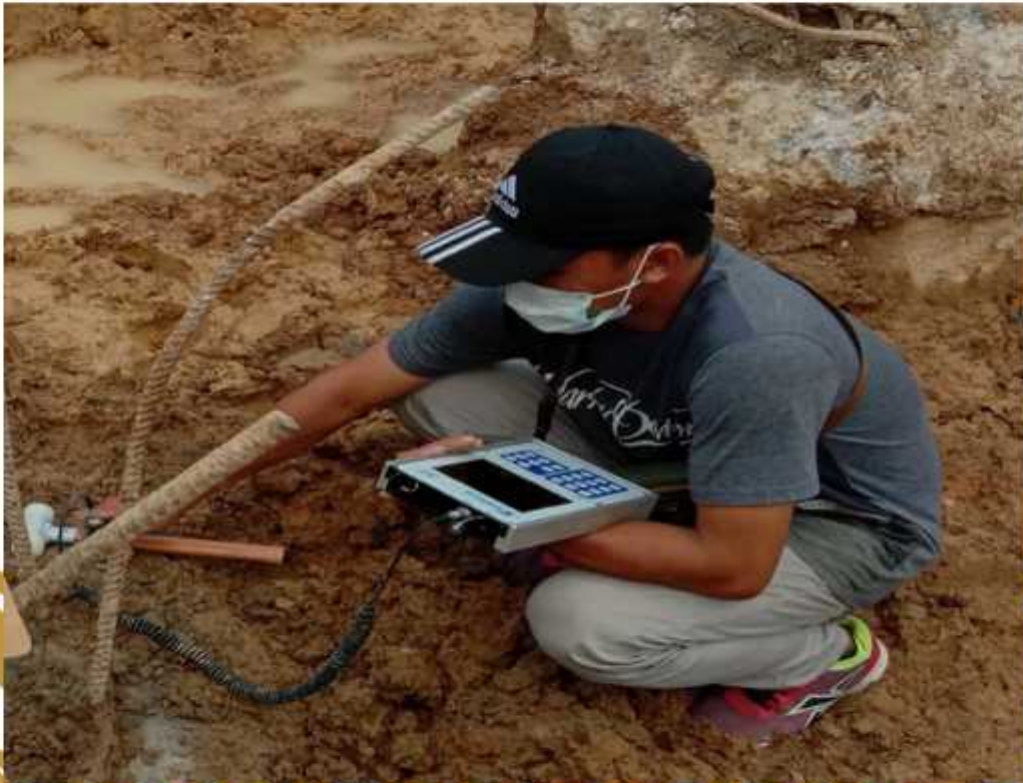
Gambar 4.3 Kondisi Di Lapangan Penelitian

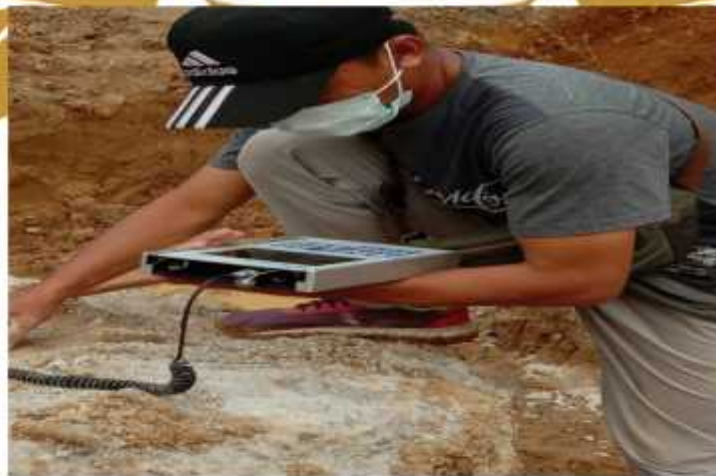
Gambar 4.1 Ujung Tiang Pondasi Dilapangan Proyek

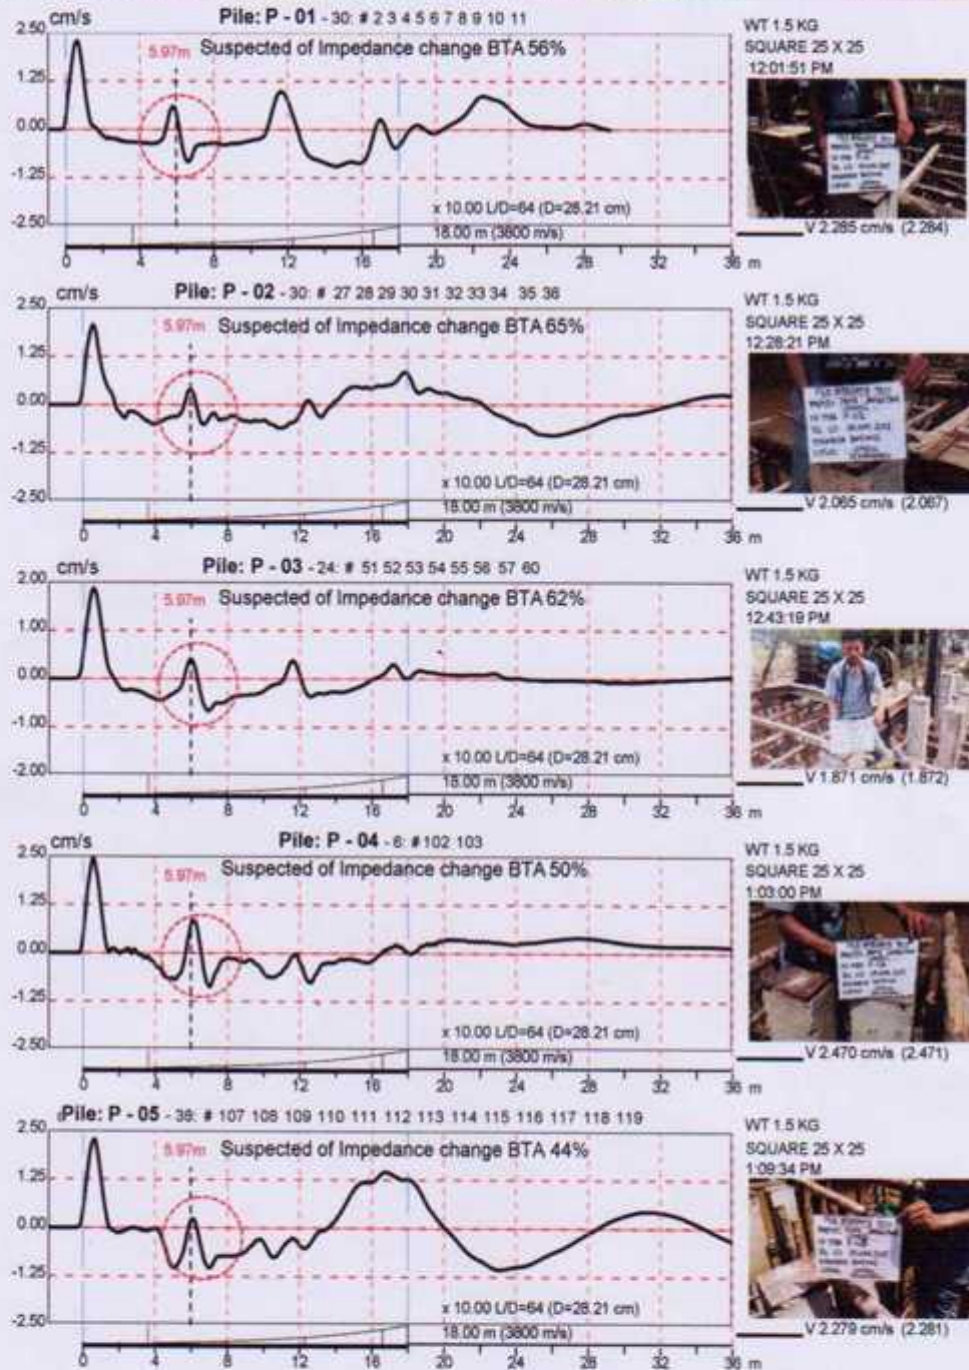
Gambar 4.2 Hasil Analisa Rambatan Gelombang Pada Penelitian Tiang Pondasi
